# Cronksbank Cottage - Retrofit Feasibility

John Gilbert Architects, with NBM Construction Cost Consultants

Final version. 5th August 2024

### 2.1. Condition Survey

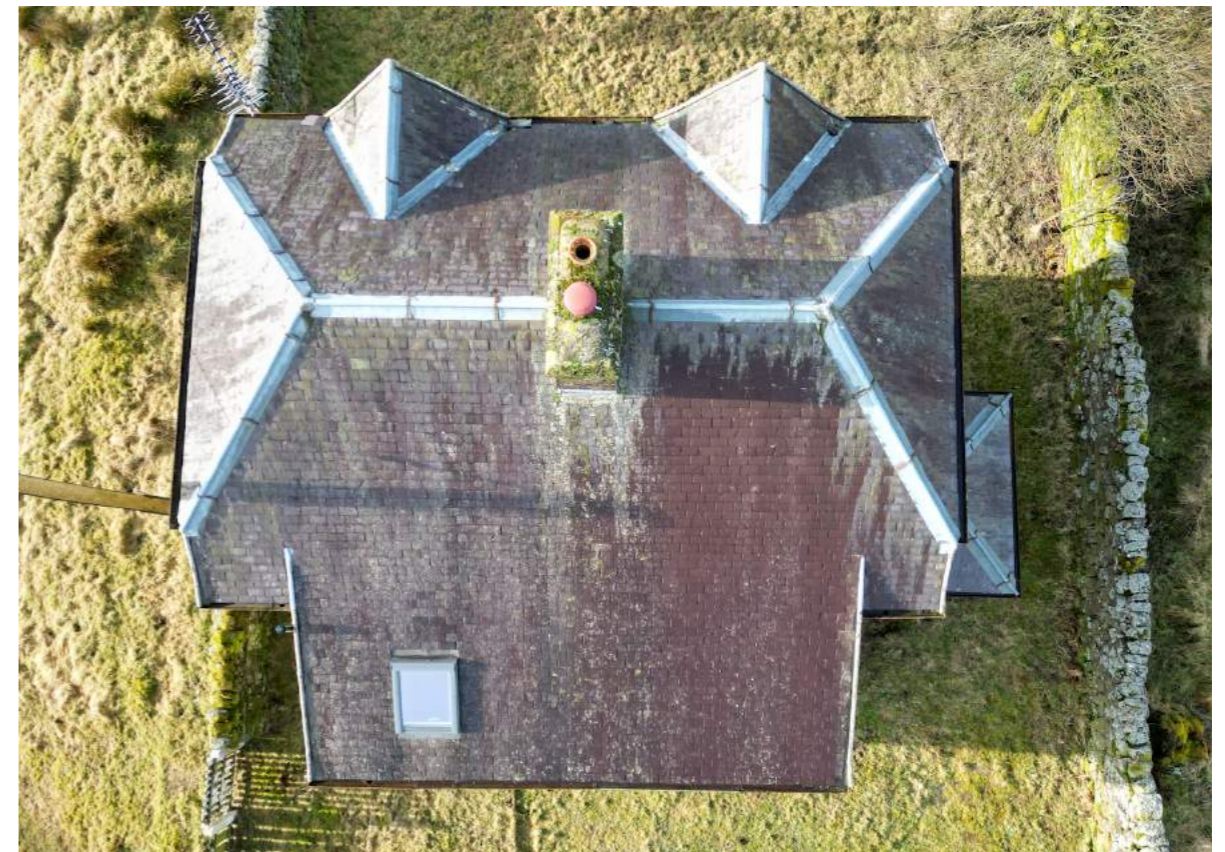
Although the image below is reproduced quite small, careful study of the drone images reveals that the slate finish itself is in very good condition. There are only one or two slipped slates and those that can be seen in some of the valley areas are not slipped, but have been put there deliberately in what we believe is an ill-judged attempt to reduce the water ingress problems (refer to rainwater goods, below). In addition, some areas show a mix of algal-covered and clean slates which suggests that the roof has been relatively recently repaired. We will propose that a small amount of money is set aside to check a range of things on the roof but we do not anticipate any money being needed to work on the slate finish itself.

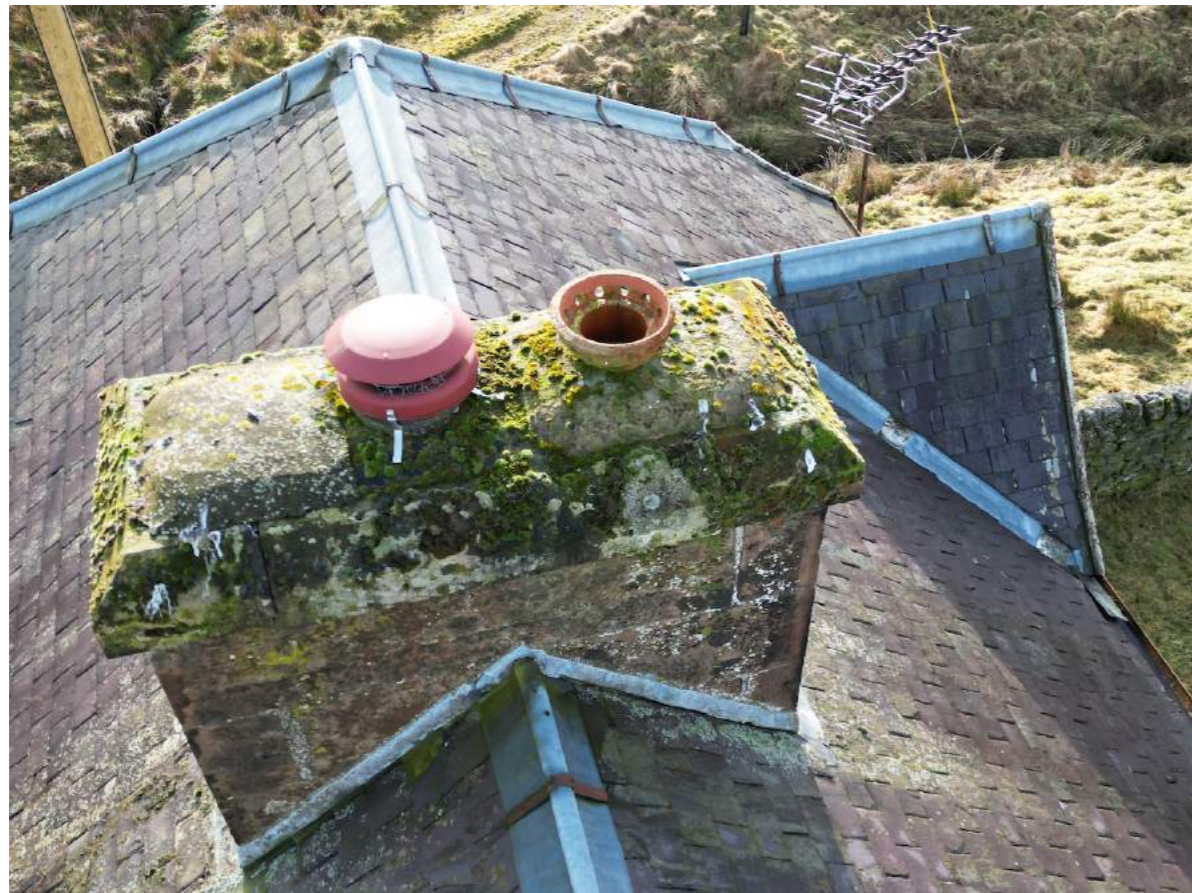
The chimney can be seen below and appears to be in good condition. It should be rubbed down to clear all moss and there looks to be a small amount of pointing needed at some open joints. The open terminal should be fitted with a vented cap to prevent rain and bird / insect ingress.

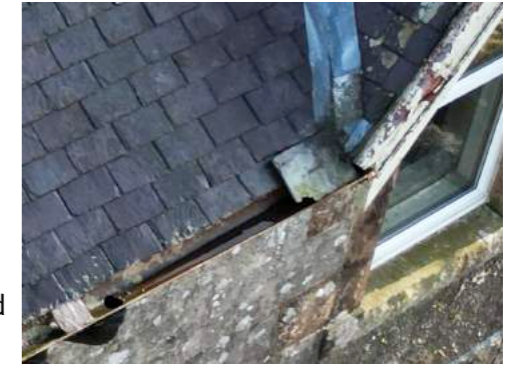
All rainwater goods are in what appears to be the original cast iron. It is black painted and in a fairly poor condition. There are also clear areas where it has dropped to create areas of pooled

water which in at least one case seems to be the reason for the water ingress, decay and mould in the main bedroom, see right. So, in certain areas these need to be re-set to drain properly to the downpipes.

It is unusual to have all cast iron pipework retained and from a conservation perspective it should all be rubbed down, joints checked and all re-painted. There is one area where there has been localised cracking of mortar around the downpipes fixing and this should all be repaired / repointed.

There is a discussion point here. From a conservation perspective it is definitely desirable to retain and repaint the existing cast iron. However, the sizes of both gutters and downpipes are small compared to what will be needed in the future with climate change and increasingly heavy downpours. From a climate change adaptation perspective, and incidentally a future maintenance perspective for LI, the best course of action is to remove all cast iron rainwater goods and replace them with black painted, larger diameter lightweight steel pipework.

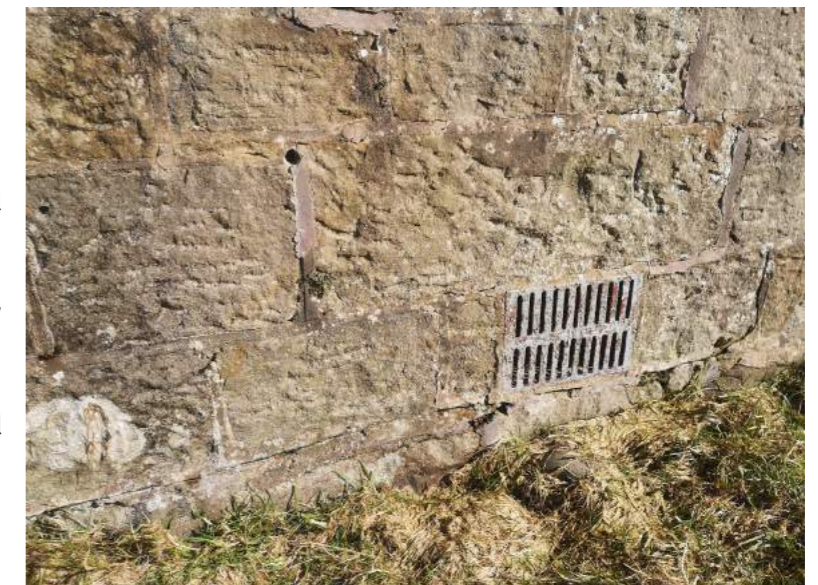
The stonework externally is generally in good condition despite being pointed in what appears to be a cement mortar. There are very few evident cracks and no evidence of surface loss. There are some areas of re-pointing, but these don't appear to betray historical cracks. Some are shown below. This is an area in the middle of the South facing wall where there is also a series of holes drilled. Such holes might ordinarily show a chemical injected damp proof course, but they only extend for a metre or so. Overall, although it would be good to get the whole stone wall repointed in lime mortar, since there are no obvious signs of disrepair, apart from filling a few small cracks and the drilled holes noted above, we don't propose to do anything remedial with the external face of the stone walls.

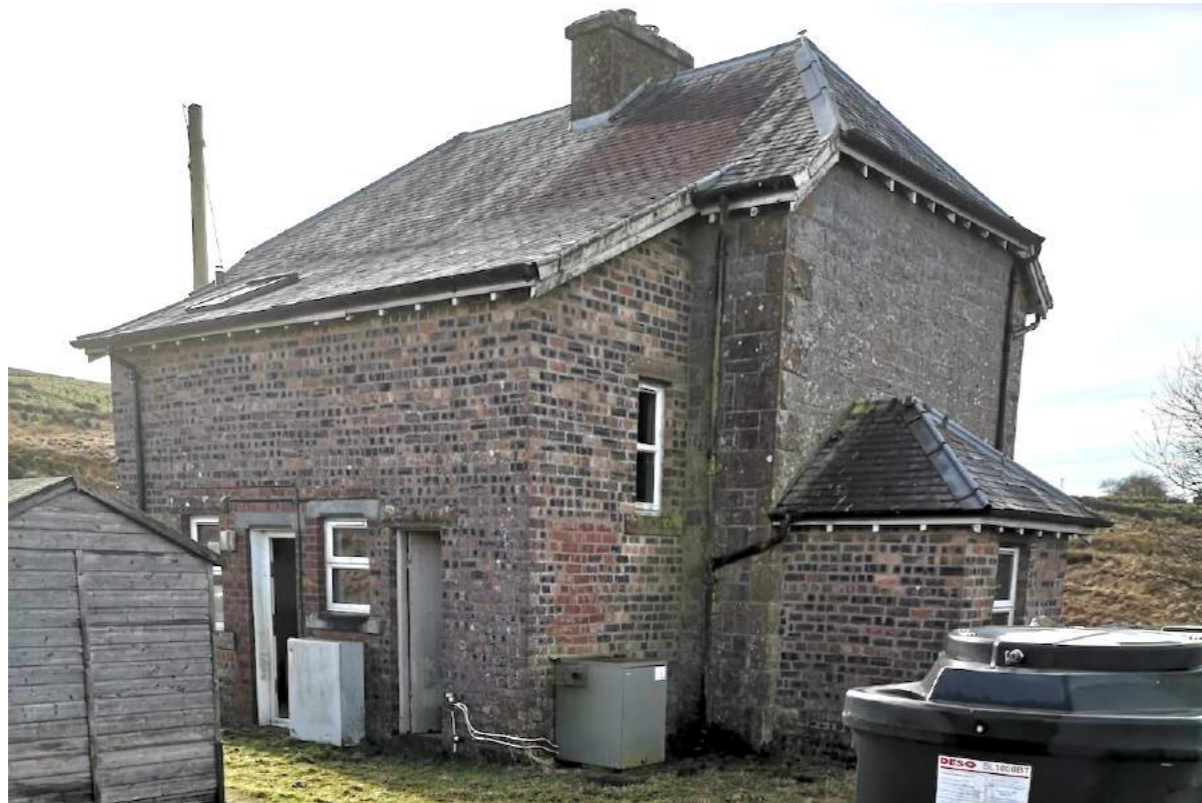
There is what appears to be an extension to the rear (North) of the property and a small porch extension to the West. See the image below which is taken from the North-West.

It appears from close inspection of the old maps that these were not part of the original building, but appeared relatively soon after. The brickwork shows signs of changes but is in good condition generally and like the stonework shows little signs of problems. There are matching stone lintels and cills to some of the windows. There is an area of missing mortar associated with a downpipe which is covered in the rainwater goods section above and cracking where the porch meets the stone house to the rear. Along with the stonework, we have suggested leaving a small sum for re-pointing but otherwise we do not propose any works to the brickwork itself.

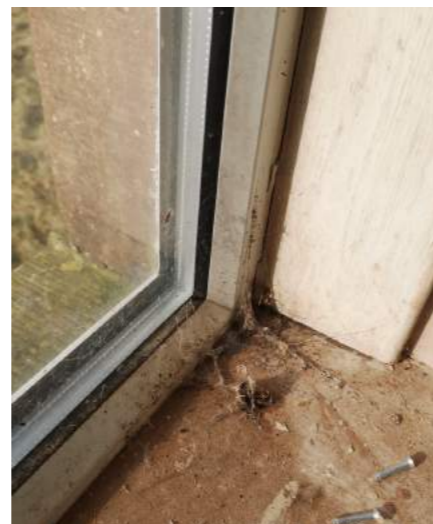
Most of the doors and windows are in need of a good clean, but in reasonable condition.

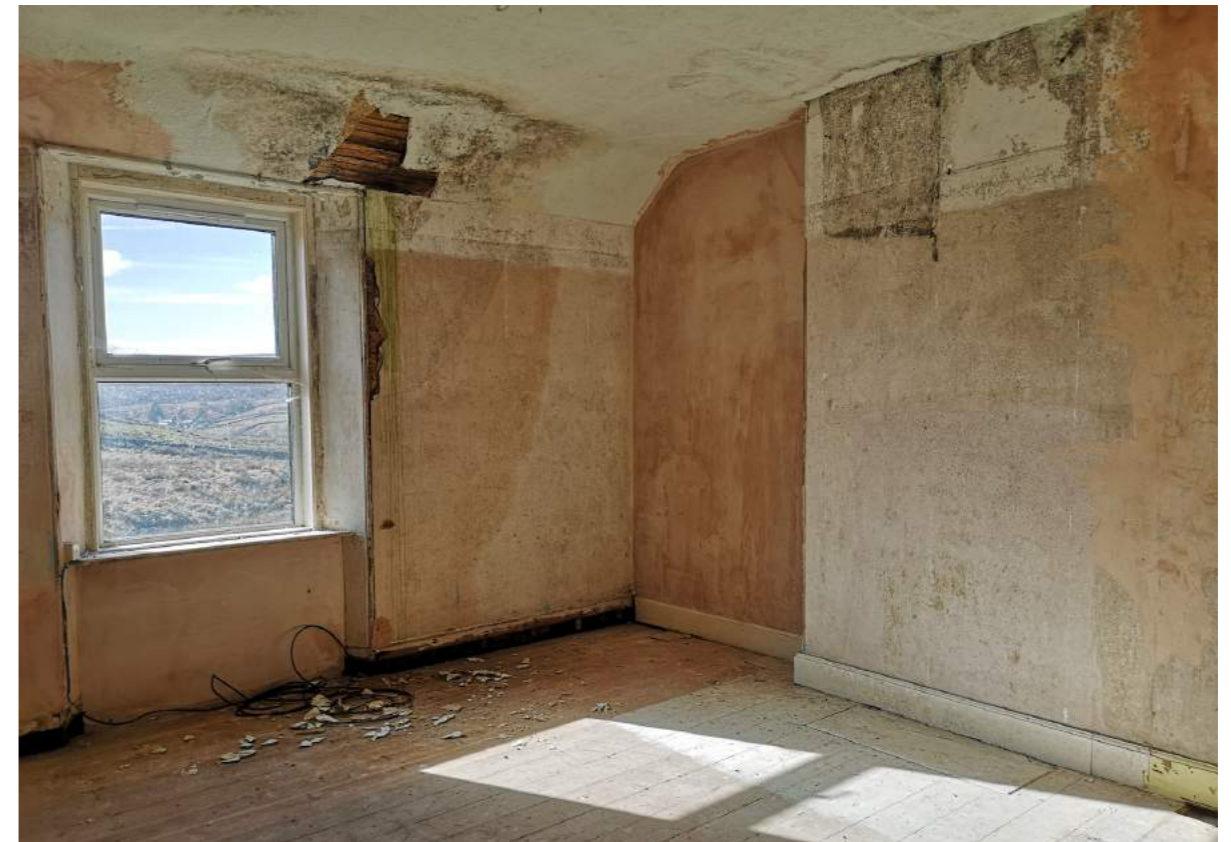
The wall and ceiling finishes internally are in a very mixed condition. Some areas, say around 20% of the total, have recently been re-plastered and are essentially good as new. The majority of the areas, say 70%, are painted or wallpapered and in reasonable or poor condition. All of these areas should probably be stripped back to the underlying plaster, with some allowance for repairs required as a result.

Another 10% or so of areas are already failed or failing and need to be entirely removed, along with, in some areas, underlying lath and plaster. The image below shows the larger bedroom (East) upstairs which demonstrates all three conditions.

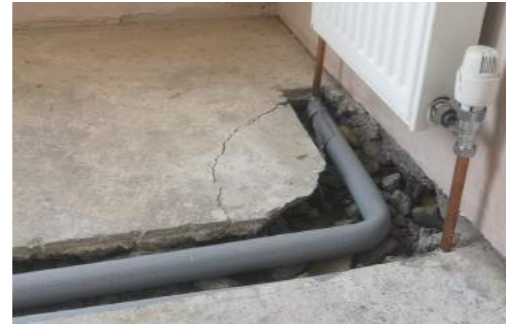
The ground floor is more complicated. The smaller bedroom downstairs features what we suspect is the only remaining area of original suspended timber floor. All other areas have been replaced with an approximately 100mm of concrete screed over hardcore and rubble. The screed has been cut into in places to run new central heating pipework to new radiators as shown below.

We do not think it is worth considering digging up the remaining areas of concrete screed and this heavily restricts what insulation is possible, so we have opted within the insulation section to install 50mm rigid high performance insulation over all floors, and lay a floating timber or laminate floor over all areas of the ground floor. Again, an allowance for infilling the existing trenches will be required.

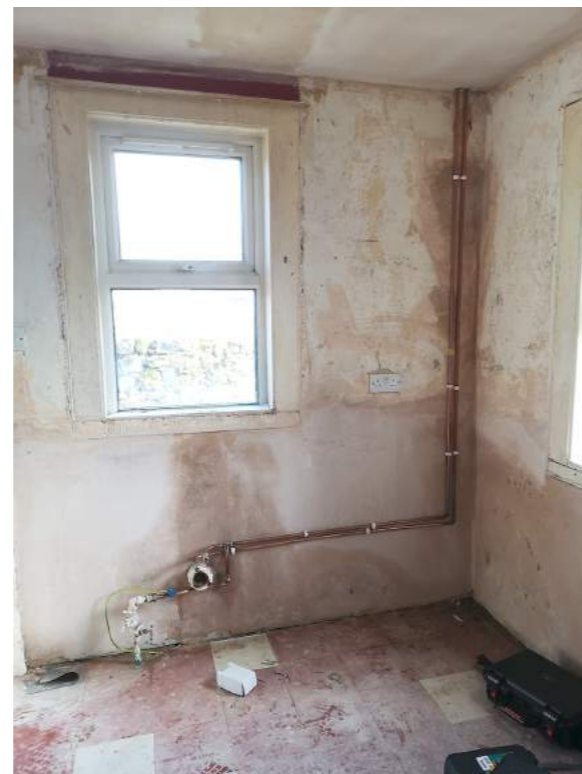
Some new pipework has been installed but there is essentially nothing in what is assumed to be the kitchen by way of kitchen units. The image below shows the existing condition. We will need to allow for all new kitchen base and wall units, worktop and fixtures, to include sink and taps etc, and inbuilt oven and hob. The volume of storage should comply with HfVN and for this reason we have moved the kitchen into the larger living space in the proposed layout. Space will be required for a fridge/freezer and washing machine. We have not allowed for a dishwasher but this can be adjusted in due course.

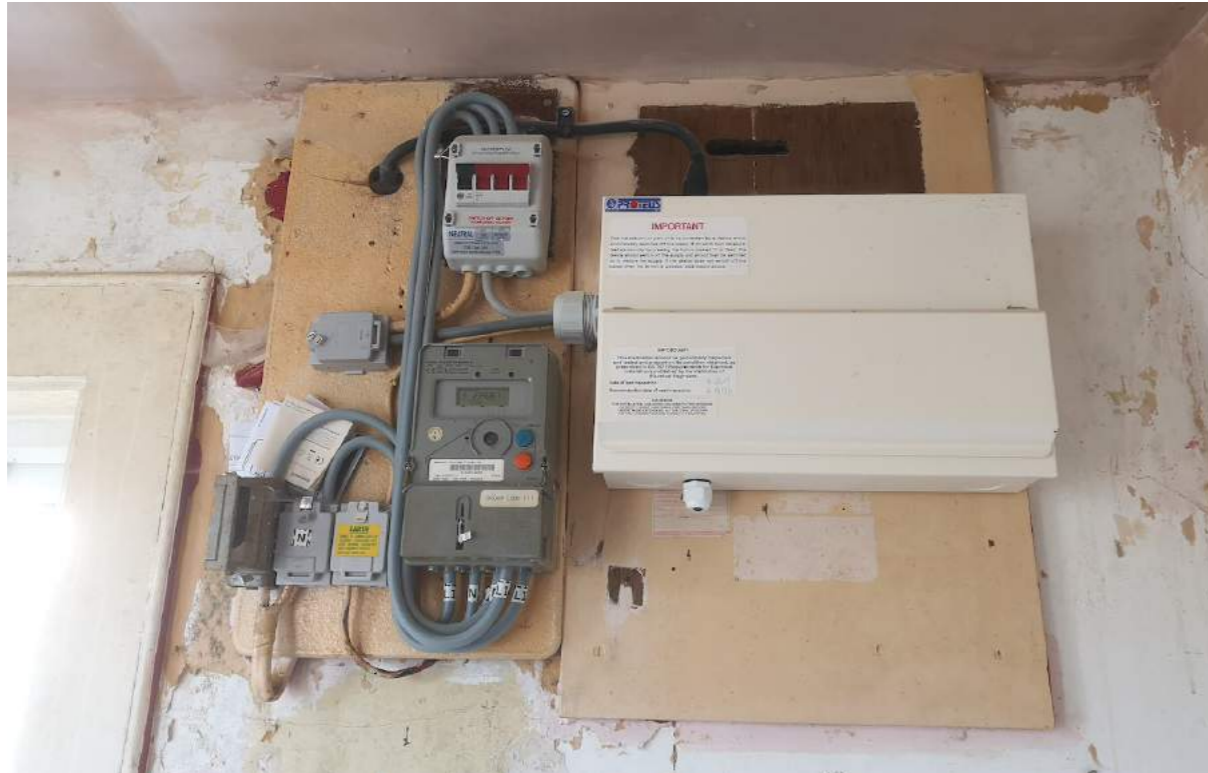
The electrical system appears to have been renewed recently as part of the works that were ongoing when the area was purchased. The distribution board in the kitchen has a note saying that the last inspection was in 2019. We have suggested that as part of any competent refurbishment, an overall electrical check would be required, but excluding the additional wiring etc required for the items noted below, we presume at this stage that that is all that is required.

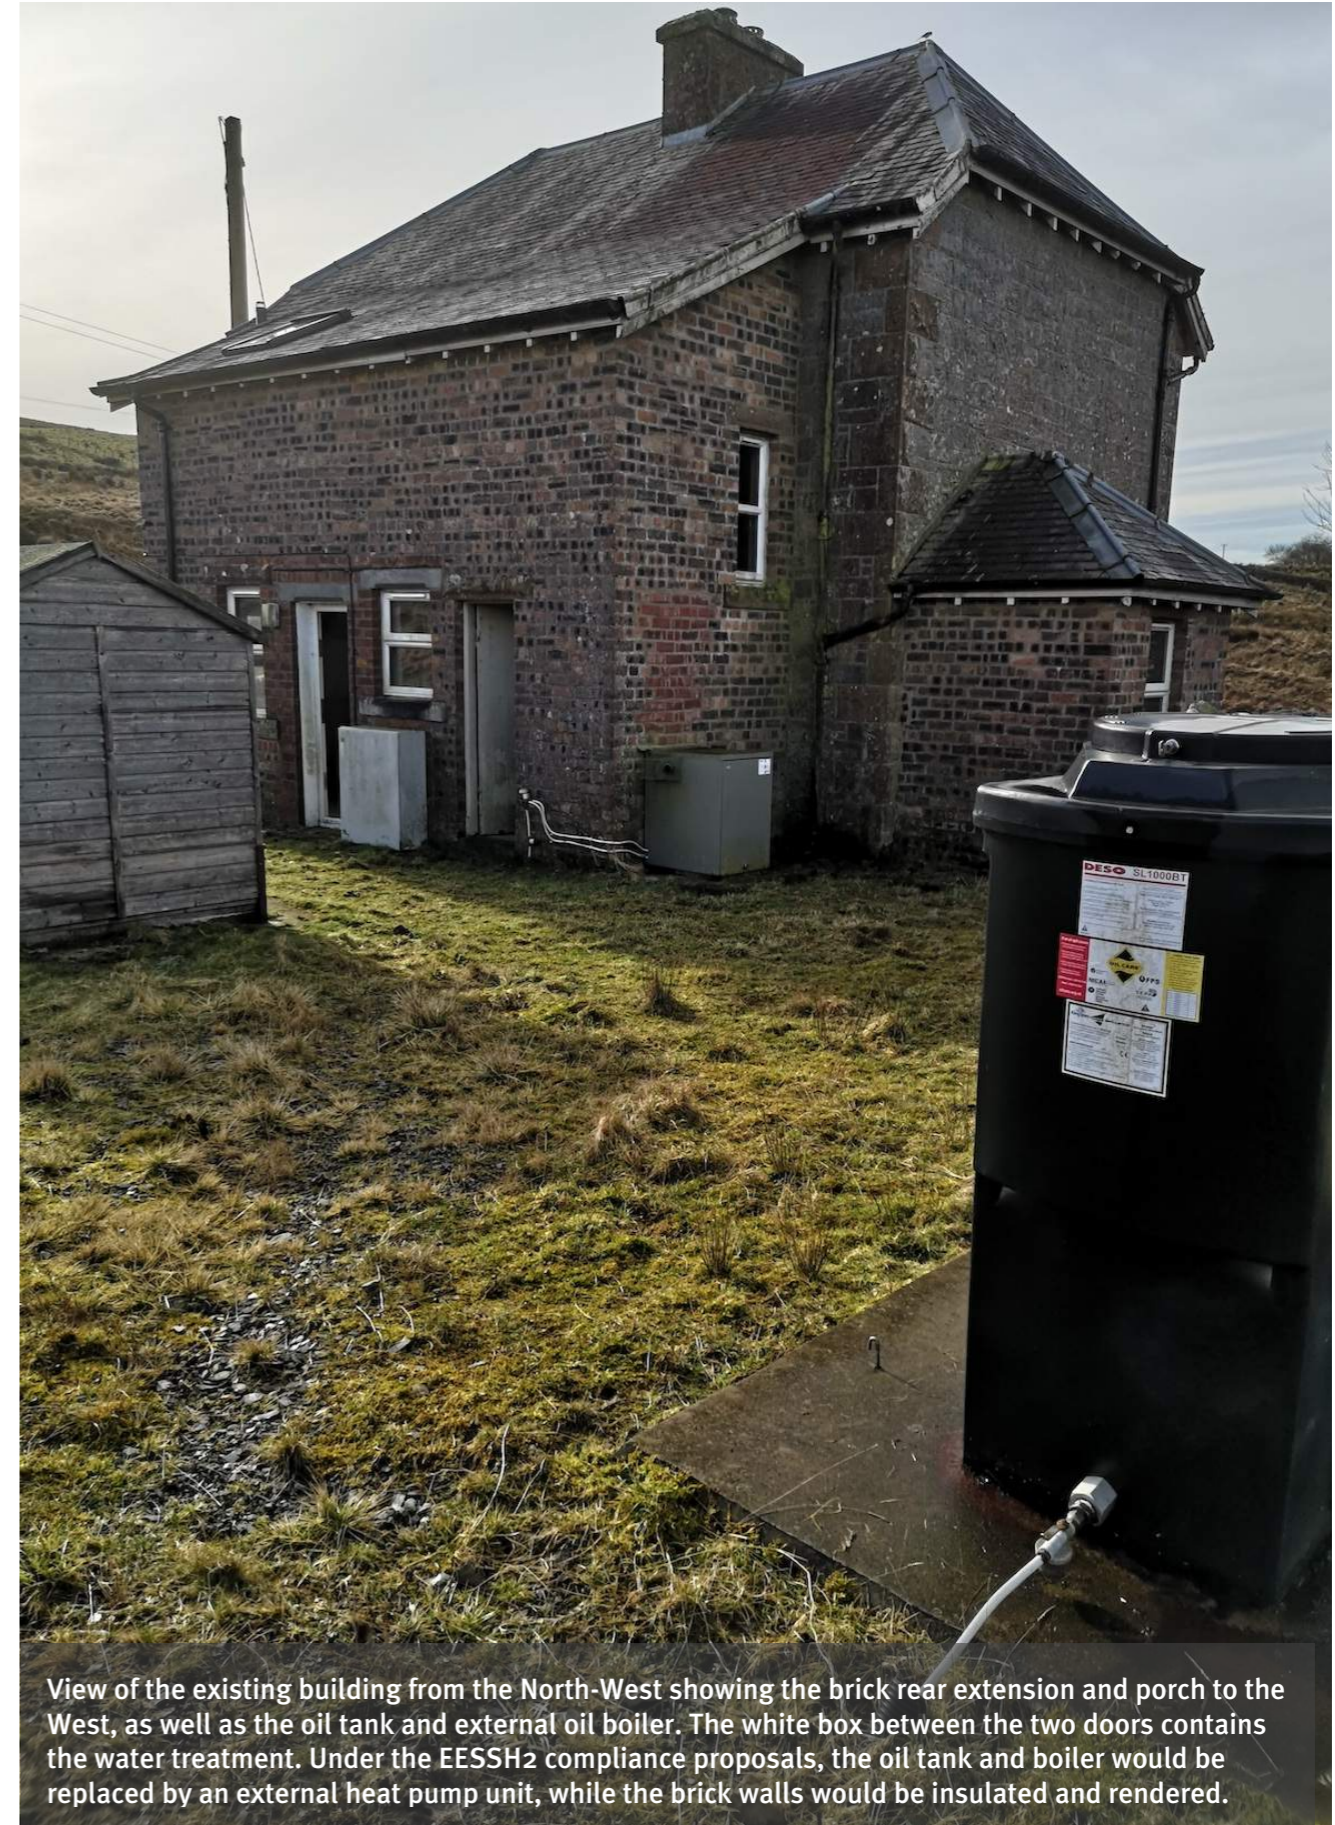
View of the existing building from the North-West showing the brick rear extension and porch to the West, as well as the oil tank and external oil boiler. The white box between the two doors contains the water treatment. Under the EESSH2 compliance proposals, the oil tank and boiler would be replaced by an external heat pump unit, while the brick walls would be insulated and rendered.
