# Cronksbank Cottage - Retrofit Feasibility

John Gilbert Architects, with NBM Construction Cost Consultants

Final version. 5th August 2024

### 2.1. Condition Survey

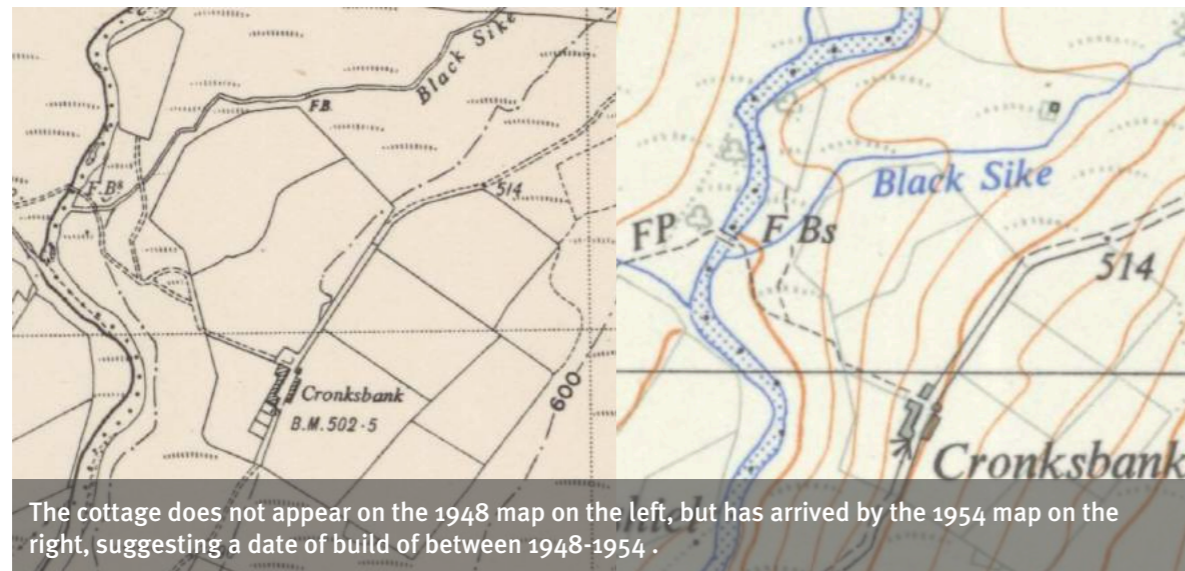
The cottage does not appear on the 1948 map on the left, but has arrived by the 1954 map on the right, suggesting a date of build of between 1948-1954 .

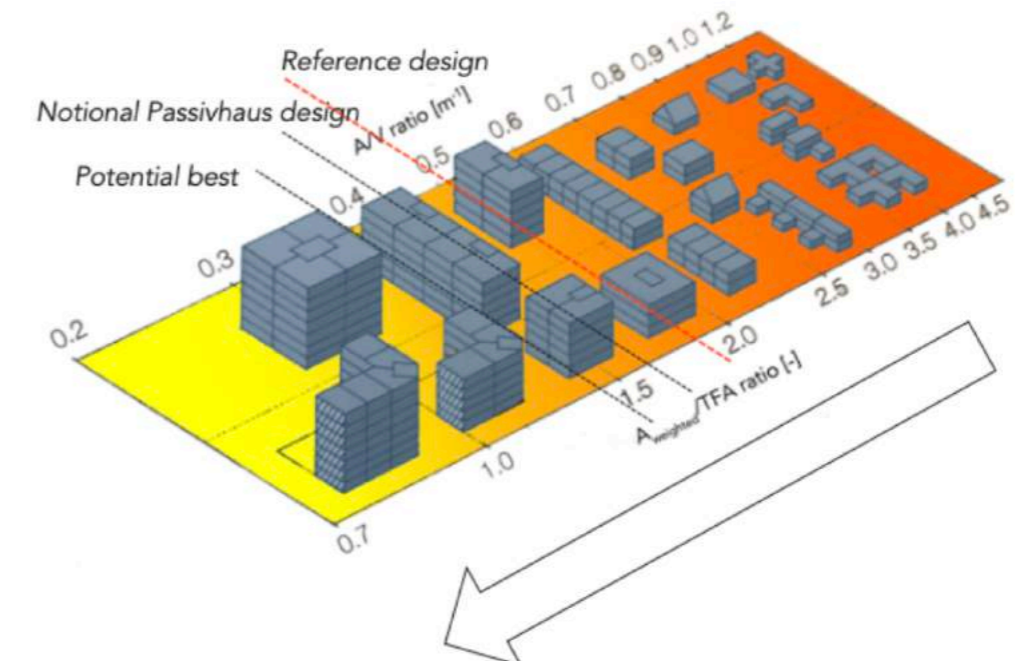
Cronksbank Cottage has a very poor form factor because it is simply quite small and has quite a few 'ins and outs' which increase its surface area. Being a two-story house (rather than single storey) helps somewhat, but in any event its form factor comes in around 3.5, which as can be seen on the scale along the bottom of the diagram below, puts it close to being about as bad as you can get!
